**CALLEGUAS MUNICIPAL WATER DISTRICT  
LAS VIRGENES-CALLEGUAS INTERCONNECTION  
PROJECT 450  
OAK PARK, VENTURA COUNTY, CALIFORNIA  
OAK TREE REPORT**

**February 2020**

**Project No. 2002-4401**

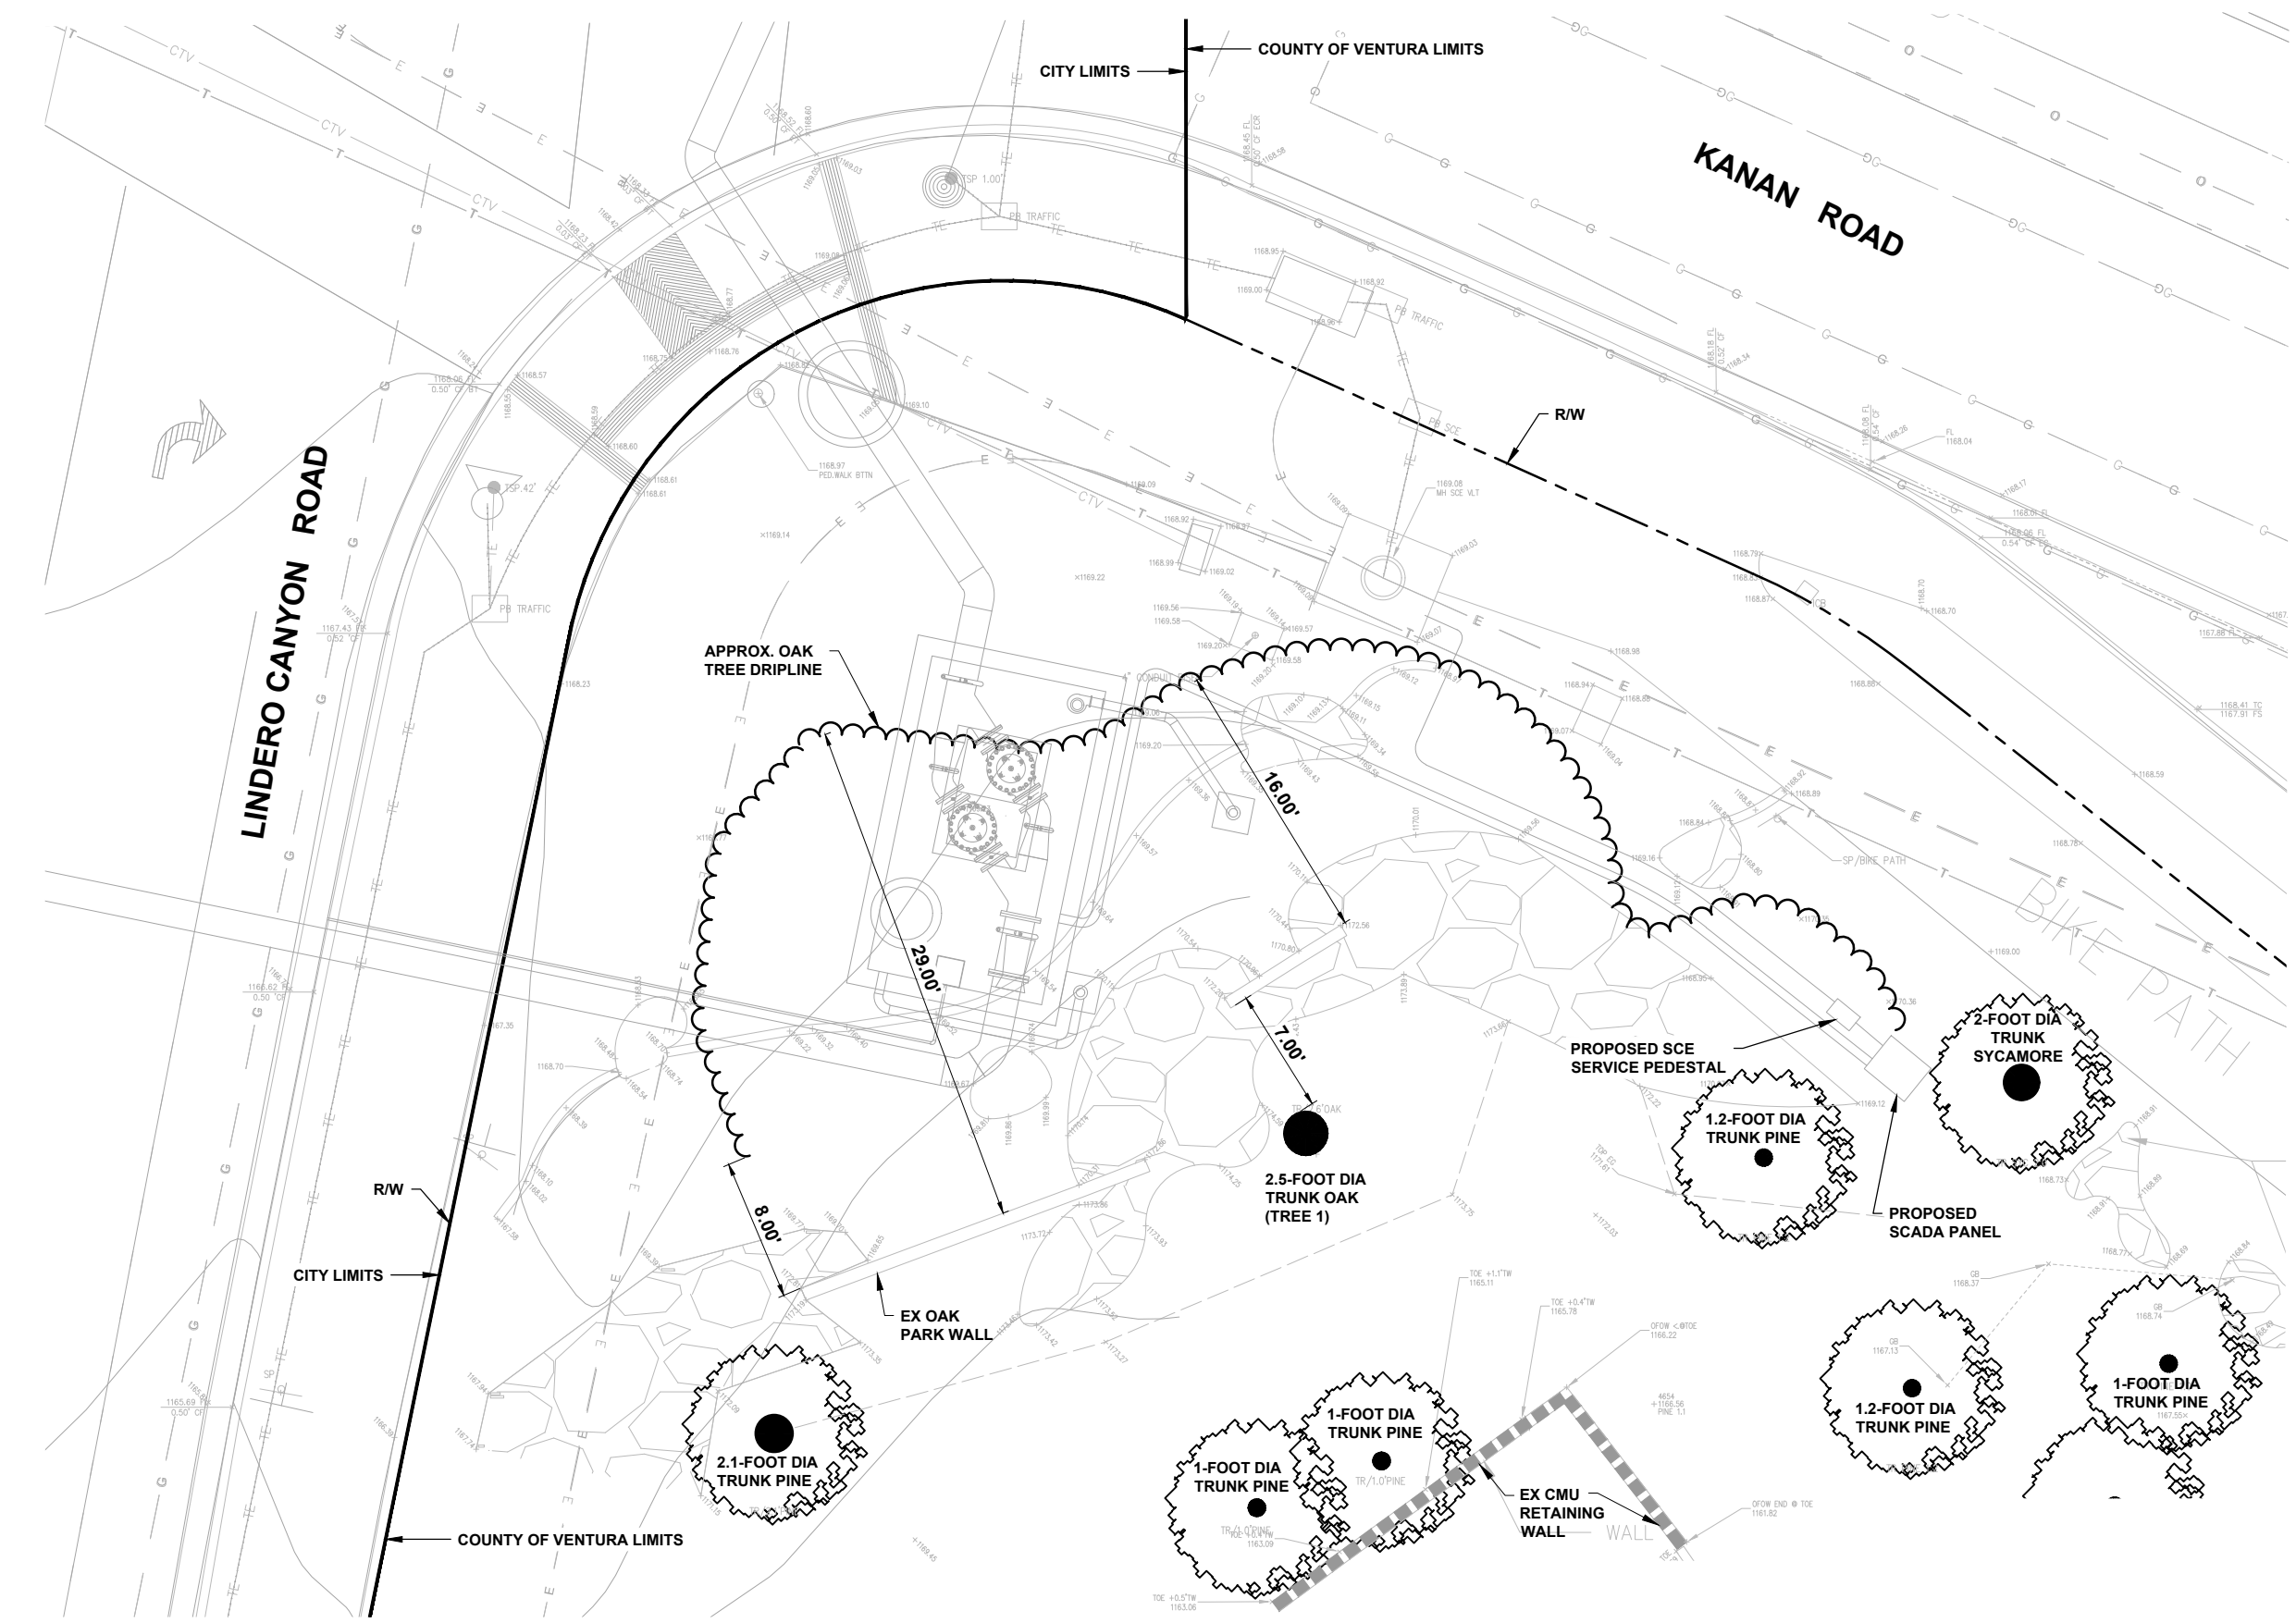
**TREE LOCATION EXHIBIT**  
 SCALE: 1" = 5'

Tree survey data was collected at the Project site on January 29, 2020. Data collected during the survey are summarized in Table 1. The tree’s location and canopy extent (dripline) are presented on the Tree Location Exhibit in Attachment A. No tree tags were observed or attached to the tree in the field.

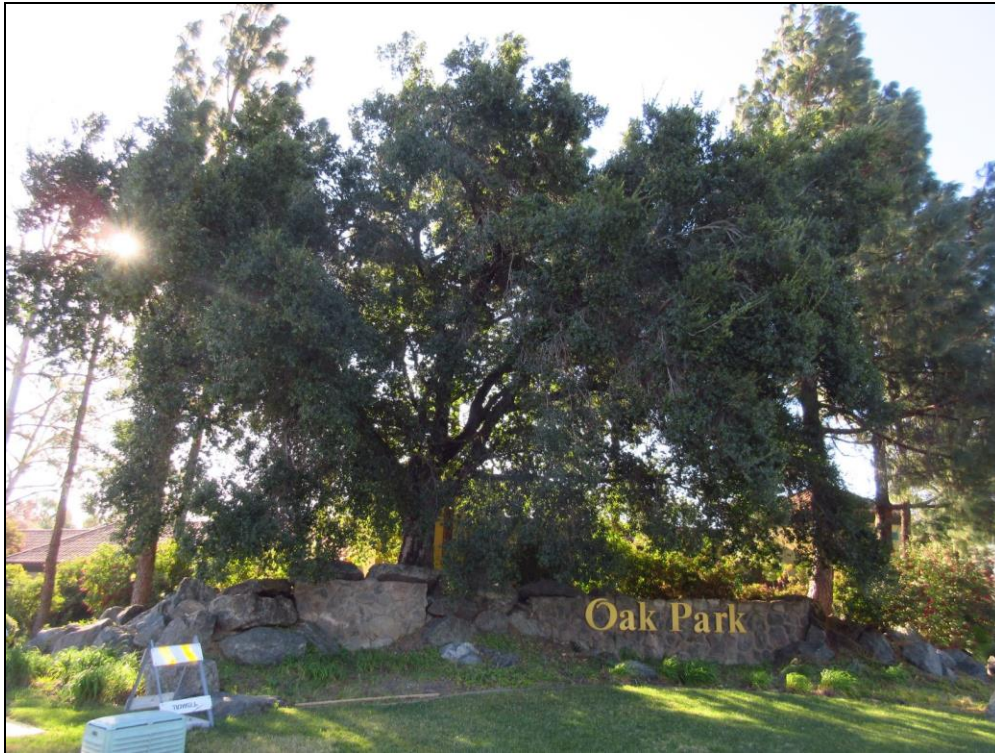
Tree 1 is a mature and apparently healthy coast live oak with one trunk and a relatively symmetrical canopy. It appears to have been planted as part of past landscaping activities along with other adjacent trees and shrubs to complement the Oak Park community sign attached to the larger of the two CMU walls. The main trunk appeared intact with numerous new growth cracks and few, if any pathological cracks (aka, “cracks of death”). The trunk diverges into scaffolding branches at seven feet off the ground where only minor evidence of bark inclusion and a shallow crotch that was collecting (mainly pine) leaves were observed. No potentially weak junctions, development of soil, water traps, or other cavities were observed in the tree. No low branching in the form of epicormic growth was observed on the main trunk. Evidence of boring insect exit holes was present, but in very low concentration, and no bark staining or other exudates were observed. No ants or other pests were observed on the trunk or main scaffolding branches.

**Figure 1.** View of Tree 1, Coast live oak tree, located on knoll above proposed work area in foreground. Photograph taken on January 29, 2020.

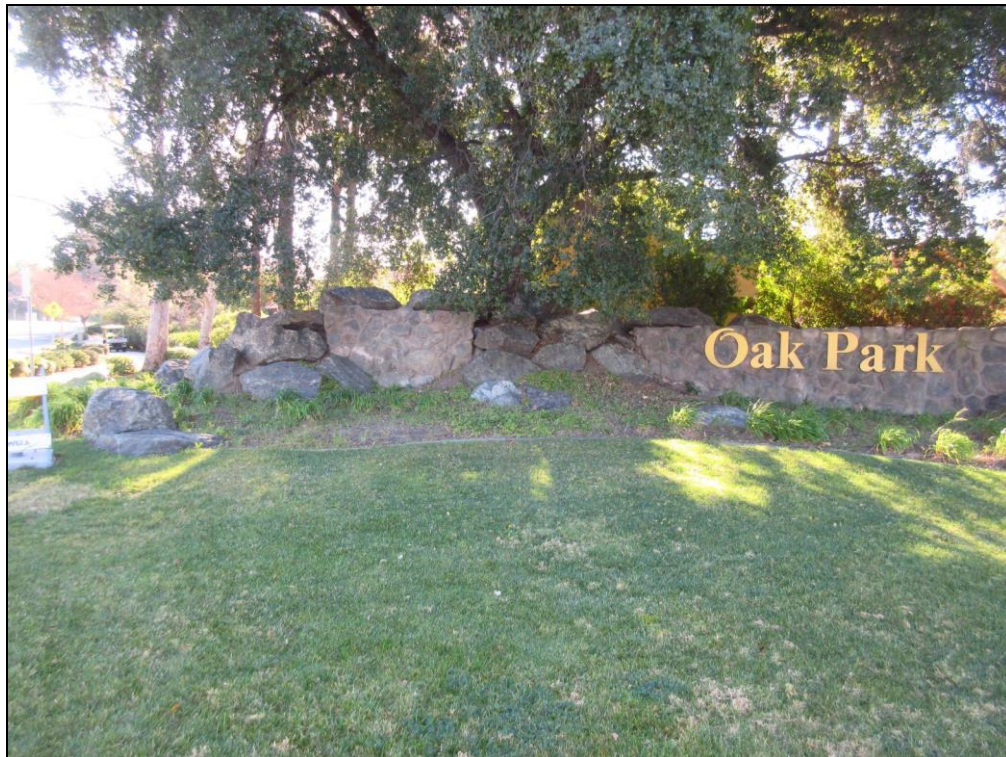
Based on the location of the new turn-out outside of the majority of Tree 1's known root crown (atop the knoll), potential root zone impacts associated with the excavation of the vault may be as low as 0 percent if no roots are encountered within the work area or as high as 10 percent if it is discovered roots have grown beneath the boulder slope and CMU wall footings down to the landscaped area below. Excavation of an approximately 50-foot-long trench from the northeast corner of the vault for a 4-inch conduit to the proposed SCADA control panel (see Tree Location Exhibit) may also encounter an additional 0 to 5 percent of Tree 1's outer root zone extent, in addition to pine and western sycamore roots.

It is our professional opinion that the most critical portion of Tree 1's root zone will be avoided and any root impacts that do occur will be considered minor. Therefore, the project is not expected to endanger the life of the tree or compromise its structural integrity. Nonetheless, there may be a low potential for the reduction of long-term vigor of the tree if minor root impacts occur.

**Figure 2.** View of proposed work area in foreground, partially beneath the canopy of Tree 1. Photograph taken on January 29, 2020.

- If possible, hand-dig the excavation and trench down into the main potential root zone to identify any roots for proper pruning to avoid tearing roots with the excavator bucket. Most tree roots are present within the upper two feet.

- Once roots are exposed, saw-cut each root flush with the trench edge.
  - Cover each cut root over 1 inch in diameter with wet burlap or backfill the trench within 5 days.

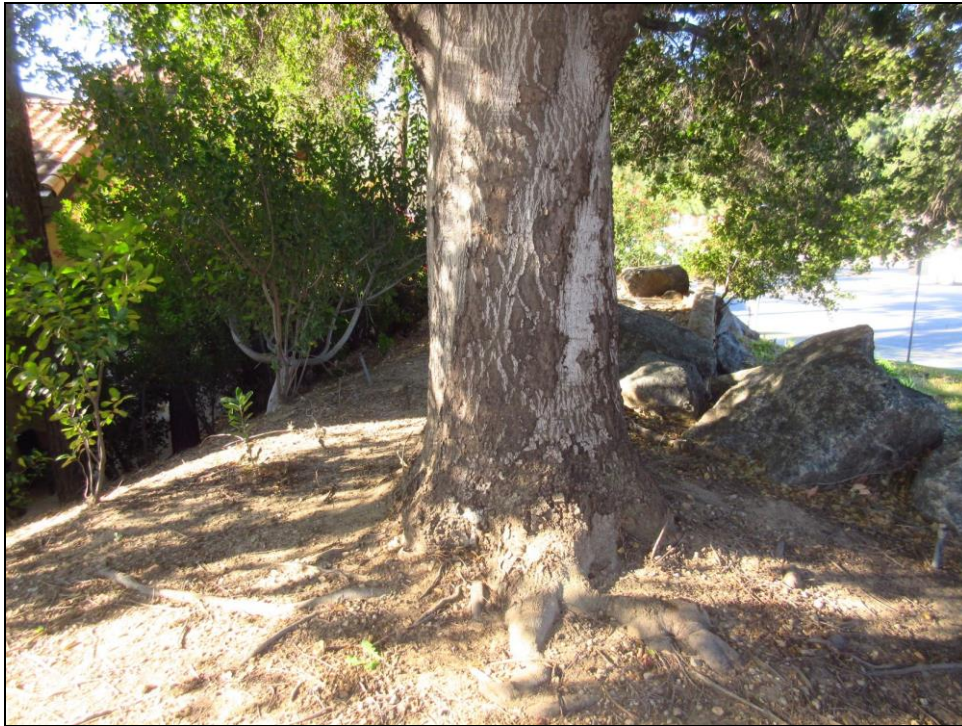
Tree roots around the base of the tree were moderately exposed and devoid of any thick organic mulch layer or wet conditions; however, sprinkler heads were observed as close as three (3) feet to the trunk. No evidence of recent irrigation or direct water spray onto the trunk or exposed root crown was observed, as appropriate to avoid root rot. The tree roots are likely mostly limited to the upper portion of the knoll as they may be constrained by the vertical cut slopes and retaining walls. However, due to the presence of an irrigation system on all sides of the tree, it is possible that some root development has occurred beneath the boulder slope and into the turfgrass patch below (i.e., into the Project work area). Evidence or potential evidence of tree roots within the work area included exposed roots from a pine tree located to the east observed between the boulder slope and bike path and slightly hummocky topography of the turfgrass patch, possibly indicating belowground roots directly within the proposed vault's footprint.

**Figure 3.** View of trunk of Tree 1, atop knoll. Photo taken on January 29, 2020.

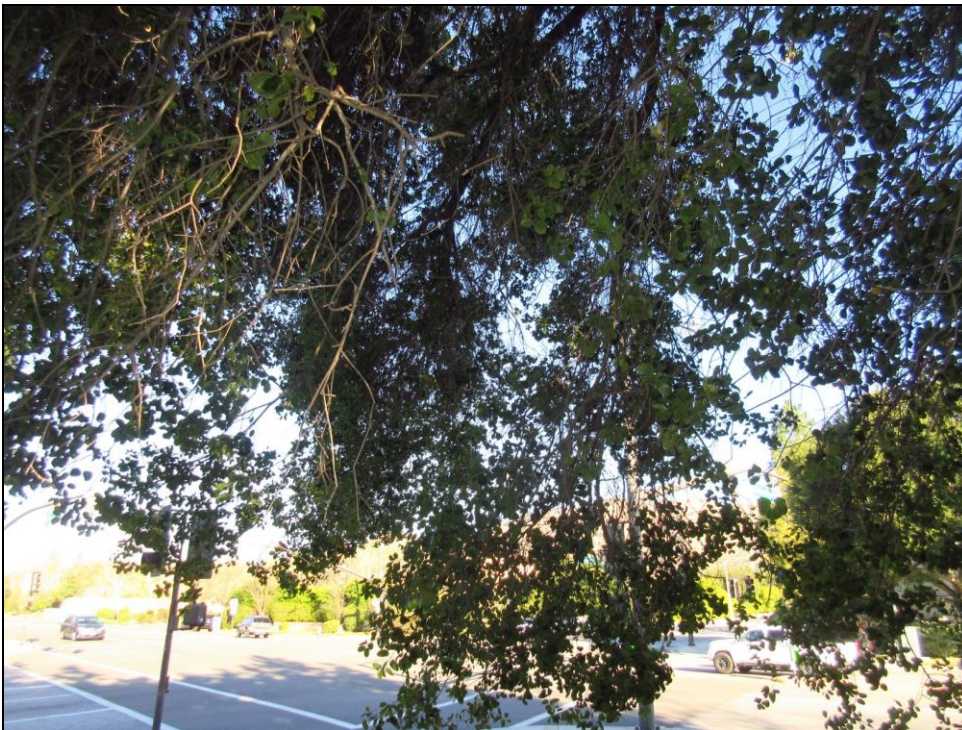
The northwest quadrant of Tree 1's canopy drapes over the proposed work area of the vault excavation to as low as 5 feet off the ground. Anticipating that a full-size excavator would be required for construction, it is estimated that approximately six (6) branches measuring between 2 and 6 inches in diameter would require removal in the lower canopy to provide sufficient vertical workspace. This amount of pruning would total approximately 5 to 10 percent of the total canopy and would not endanger the health of the tree or create any significant aesthetic impact or imbalance. Proper pruning techniques are briefly described in Attachment D, Tree Protection Measures.

**Figure 4.** View of lower canopy in northwest quadrant of Tree 1, requiring minor pruning according to current Project design. Photo taken on January 29, 2020.

- Prune overhead branches according to International Society of Arboriculture (ISA) pruning standards by hand (e.g., pole chainsaw). Avoid arbitrary cuts that may leave a portion of deadwood on the tree to reduce pest infiltration. Cut at 1 inch above the “branch bark collar” (a patch of rough bark that is the growth center) at an angle perpendicular to the cut branch, not the scaffolding branch or trunk. All cuts shall be conducted by a qualified tree trimmer or overseen by a Certified Arborist who can direct the chainsaw operator to the correct cut locations.
