## **GEOTECHNICAL REPORT**

# **LINDERO CANYON PIPELINE ALIGNMENT, LAS VIRGENES MUNICIPAL WATER DISTRICT / CALLEGUAS MUNICIPAL WATER DISTRICT INTERCONNECTION PROJECT (PROJECT 450), THOUSAND OAKS, CALIFORNIA**

February 2019  
Job No. 003.001

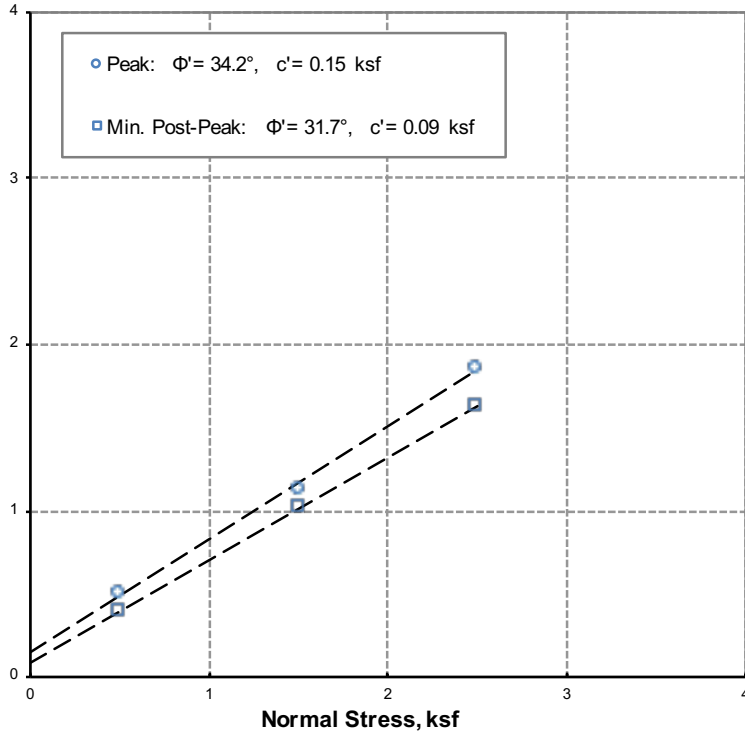
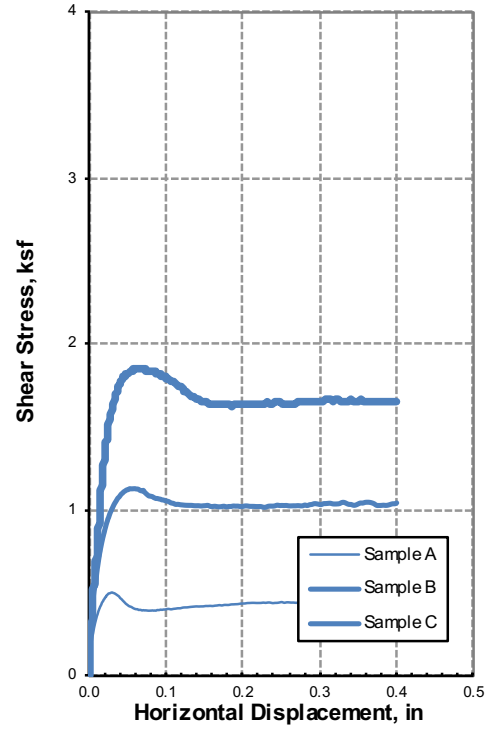
<b>SAMPLE ID</b>	Boring Number:	DH-2			
	Sample Number:	3			
<b>INITIAL</b>	Sample Depth:	4.0 ft			
	USCS Classification:	Clayey SAND (SC): red brown, moist			
<b>INITIAL</b>	Specimen	A	B	C	D
	Water Content, %	12.6%	12.6%	12.6%	
	Dry Unit Weight, pcf	109.0	109.1	113.0	
	Saturation, %	64%	64%	71%	
	Void Ratio	0.53	0.53	0.47	
<b>FINAL</b>	Diameter, in	2.42	2.42	2.42	
	Height, in	1.00	1.00	1.00	
	Water Content, %	21.4%	18.9%	17.6%	
<b>TEST SUMMARY</b>	Dry Unit Weight, pcf	104.9	108.7	113.1	
	Void Ratio	0.59	0.53	0.47	
	Displacement at Peak, in	0.03	0.06	0.06	
	Displacement Rate, in/min	0.001	0.001	0.001	
	Normal Stress, ksf	0.5	1.5	2.5	
	Peak Shear Stress, ksf	0.50	1.13	1.85	
<b>REMARKS</b>	Min. Post-Peak Stress, ksf	0.39	1.02	1.63	
	Project: Lindero Canyon Road Pipeline Test Method: ASTM D3080

<b>CLASSIFICATION</b>	Sieve Size	% Passing
	3/8-in. (9.5mm)	---
	#4 (4.75mm)	---
	#16 (1.18mm)	---
	#30 (0.6mm)	---
	#100 (0.150mm)	---
	#200 (0.075mm)	---
Atterberg Limits		
Liquid Limit, %	---	
Plastic Limit, %	---	
Plasticity Index, %	---	
Estimated Gs	2.67	
k <sub>avg</sub> 20°C, cm/sec	---

**DIRECT SHEAR TEST**

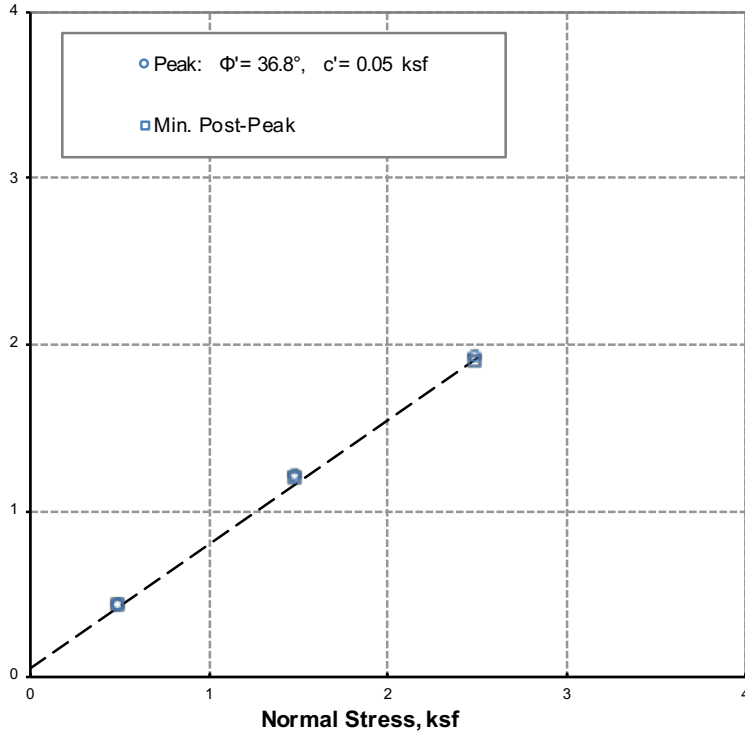
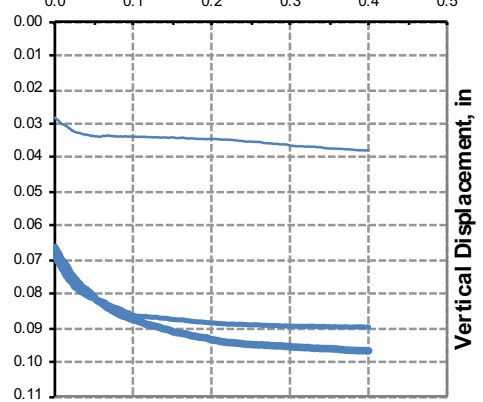
<b>SAMPLE ID</b>	Boring Number:	DH-4			
	Sample Number:	4			
	Sample Depth:	10.0 ft			
	USCS Classification:	Clayey SAND (SC): brown, moist			
<b>INITIAL</b>	Specimen	A	B	C	D
	Water Content, %	13.9%	13.9%	13.9%	
	Dry Unit Weight, pcf	98.3	95.6	95.4	
	Saturation, %	55%	52%	51%	
	Void Ratio	0.65	0.70	0.70	
	Diameter, in	2.42	2.42	2.42	
	Height, in	1.00	1.00	1.00	
<b>FINAL</b>	Water Content, %	22.9%	20.0%	21.1%	
	Dry Unit Weight, pcf	98.6	103.0	100.4	
	Void Ratio	0.65	0.58	0.62	
<b>TEST SUMMARY</b>	Displacement at Peak, in	0.40	0.39	0.35	
	Displacement Rate, in/min	0.001	0.001	0.001	
	Normal Stress, ksf	0.5	1.5	2.5	
	Peak Shear Stress, ksf	0.42	1.20	1.92	
	Min. Post-Peak Stress, ksf	0.42	1.18	1.88	
<b>REMARKS</b>	Project:	Lindero Canyon Road Pipeline			
	Test Method:	ASTM D3080

<b>CLASSIFICATION</b>	Sieve Size	% Passing
	3/8-in. (9.5mm)	---
	#4 (4.75mm)	---
	#16 (1.18mm)	---
	#30 (0.6mm)	---
	#100 (0.150mm)	---
	#200 (0.075mm)	---
Atterberg Limits		
	Liquid Limit, %	---
	Plastic Limit, %	---
	Plasticity Index, %	---
	Estimated Gs	2.6
	k <sub>avg</sub> 20°C, cm/sec	---
